Home Inspection Report

1234 New Street
Better City, North Carolina 27215

Date of Inspection: Saturday, February 28, 2015

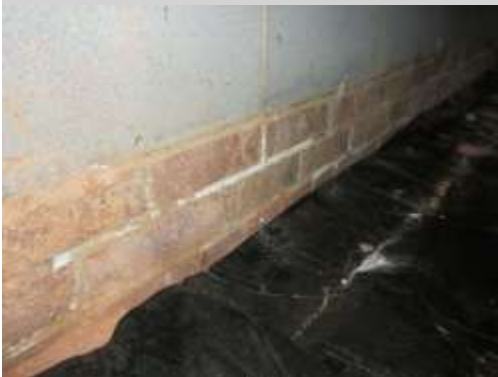
(A1 - 1.1) Main House

Efflorescence (salt stains) was noted on the foundation walls. The stains indicate that the foundation was been cyclically wet and dry. Water penetration into the foundation area can result in structural damage and undesirable environmental conditions. Water in the foundation area indicates an absent or damaged waterproofing and foundation drain systems. Repairs are needed to prevent water penetration. A general contractor should be consulted for further evaluation to determine the source of the moisture and to make necessary repairs.

Efflorescence (salt stains) was noted on the foundation walls. The stains indicate that the foundation was been cyclically wet and dry.

Water penetration into the foundation area can result in structural damage and undesirable environmental conditions. Water in the foundation area indicates an absent or damaged waterproofing and foundation drain systems. Repairs are needed to prevent water penetration. A general contractor should be consulted for further evaluation to determine the source of the moisture and to make necessary repairs.

Refer to the exterior section of the report concerning the lot grading.

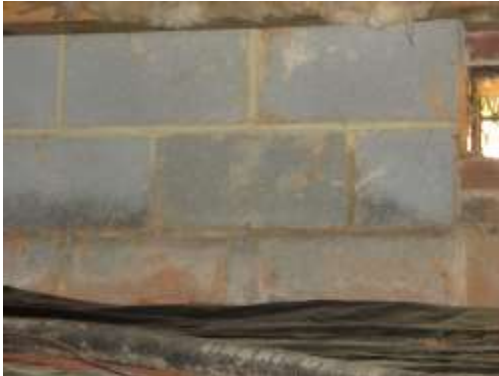
(A1 - 1.2) Main House

Stains and water lines indicate a history of standing water in the crawl space around the perimeter of the foundation and under the porches. Direct water penetration damages the foundation, the wood structure, and creates an undesirable environment in the crawl space areas that encourages insect, fungal growth such as mold/mildew. Repairs are needed to prevent water penetration. Water in the crawl space indicates an absent or damaged waterproofing and foundation drain system. Repairs are needed to prevent water penetration. A general contractor should be consulted for further evaluation to determine the source of the moisture and to make necessary repairs.

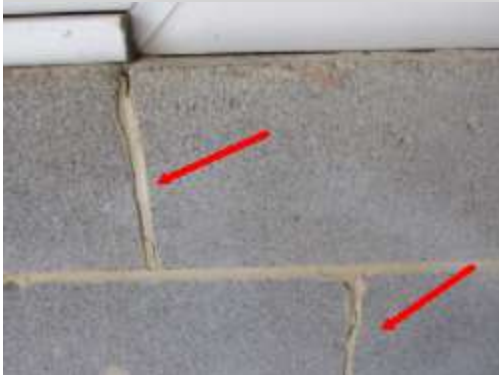
(A1 - 2.1) Garage

Closed cracks were noted in the foundation of the garage at locations where the foundation steps related to elevation change. Cracks in the foundation indicate a deficiency in the foundation, footing, or supporting soil that can change and worsen if it progresses over the life of the home. An engineer should be consulted to determine the significance /cause of the cracks and outline any necessary repairs.

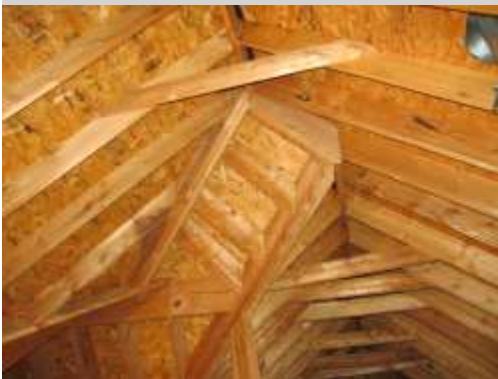
(A6 - 1.1) Main House

From the attic, it was noted that the Valley/Hip rafter located between the main home and first floor room was not posted for end support. End post supports are typically installed to supplement nailed joints and ensure the stability of the roof system. An engineer should be consulted for further evaluation to determine the significance and cause of the concern and outline necessary repairs to ensure the stability of the structure.

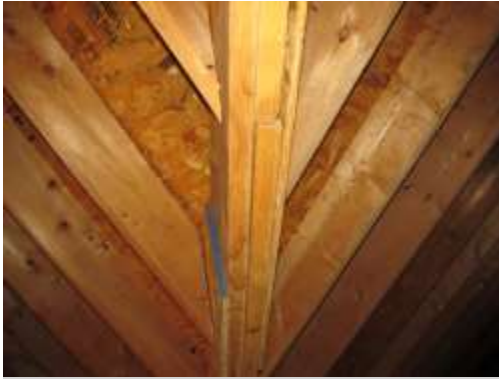
(A6 - 1.2) Main House

From the attic, it was noted that the valley rafter located over the main living room was constructed of multiple members and was not posted for support. Post supports are typically installed to supplement nailed joints and ensure the stability of the roof system. An engineer should be consulted for further evaluation to determine the significance and cause of the concern and outline necessary repairs to ensure the stability of the structure.

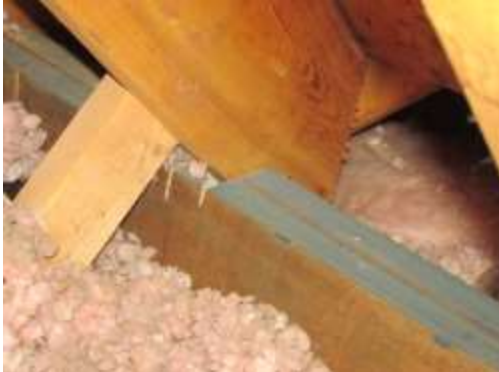
(A6 - 1.3) Main House

The LVL girder located under the main rafters on the front side of the home has been notched for rafter installation. Engineered lumber beams have specific installation specifications that rarely allow notching. If a notch is beyond what would be typically expected and could result in cracking or failure of the beam. A girder is a main structural component that provides support of the framing structure and transfers loads to the foundation. An engineer should be consulted for further evaluation to determine the significance of the concern and outline necessary repairs to ensure the stability of the structure.

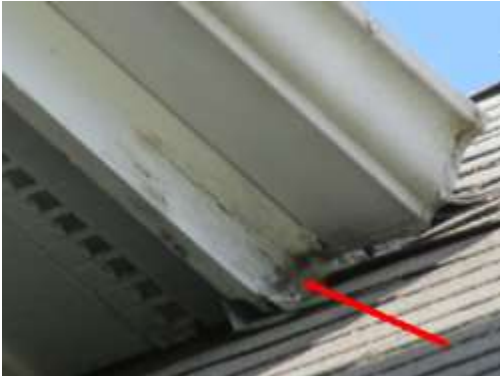
(B1 - 1.1) Main House Front

The exterior boxing of the home need repairs and painting to prevent further damage and water penetration. The following items were noted during the inspection all areas should be evaluated as a repair plan is prepared:

1. Peeling paint, swollen edges behind the gutter trays;
2. Boxing and trim areas were found to have area of decay at roof line intersections

A licensed general contractor should be consulted for a complete evaluation of the trim and boxing to determine the scope of the damage and make necessary repairs.

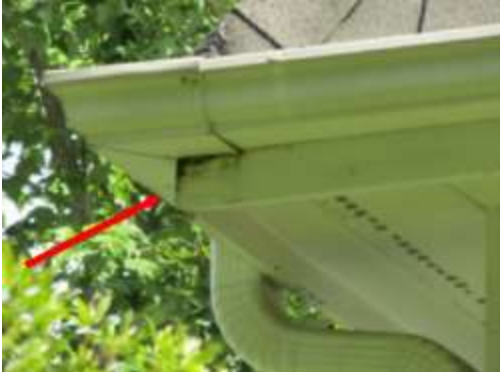
(B1 - 1.2) Main House Front

Additional Photograph: This a photograph of decayed boxing at the left front corner of the main home. All corner trims areas were noted to have some level of decay.

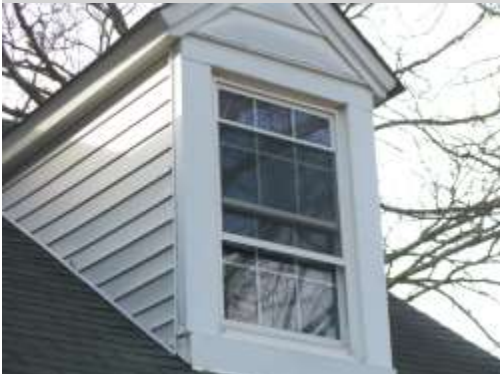
(B1 - 1.3) Main House Front

The trim cladding along the roof rake / eave was not formed to provide a lip to support the shingles and prevent water from traveling behind the trim. A siding installation company or general contractor should be consulted to evaluate and repair the trim to ensure the integrity of the cladding system.

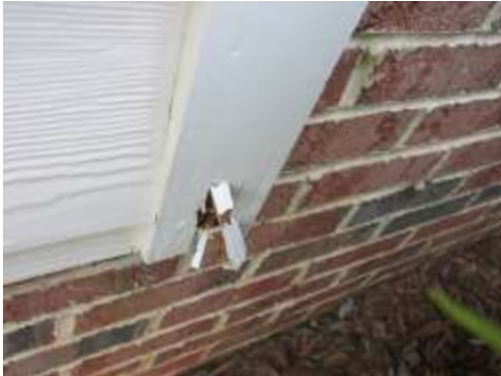
(B1 - 2.1) Main House Rear and Sides

The exterior trim of the home need repairs and painting to prevent further damage and water penetration. The following items were noted during the inspection all areas should be evaluated as a repair plan is prepared:

1. Corner trim moldings have visible areas decay.
2. Vertical wood trim boards at corner and brick intersections have visible areas of decay.

A licensed general contractor should be consulted for a complete evaluation of the exterior trim to determine the scope of the damage and make necessary repairs.

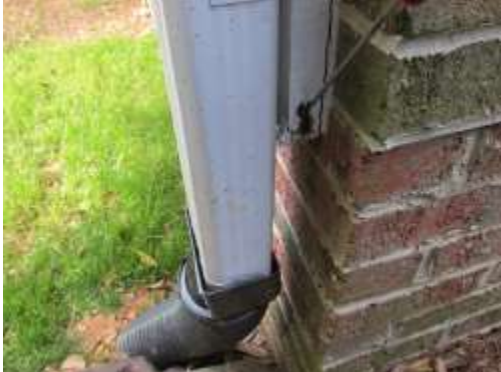
(B1 - 2.2) Main House Rear and Sides

Additional Photograph: This a photograph of a decayed vertical trim molding behind the back left gutter.

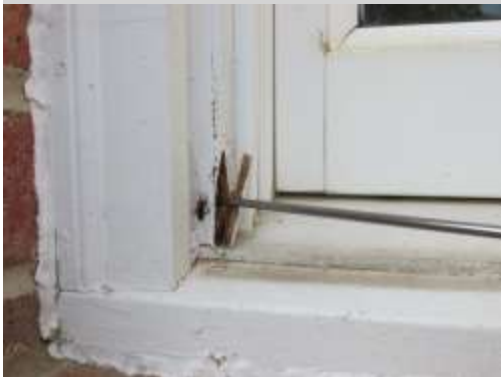
(B2 - 1.1) All Windows

The all windows have soft and decayed wood in the sill, trim, sash areas. Decay in the windows can result in leaking and water penetration and should be repaired as soon as possible. All windows should be inspected for similar damage as repairs are made. A licensed general contractor should be consulted to evaluate the extent of the damage and make necessary repairs.

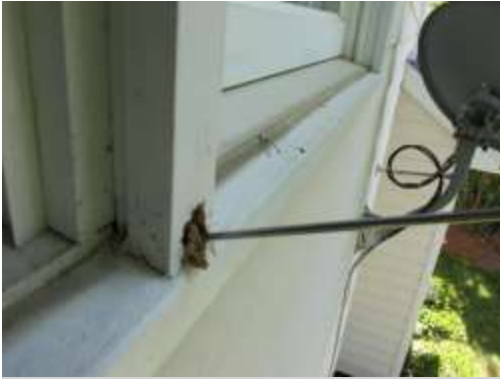
(B2 - 1.2) All Windows

Additional Photograph: This a photograph of the living room window, the trim between the windows is decayed.

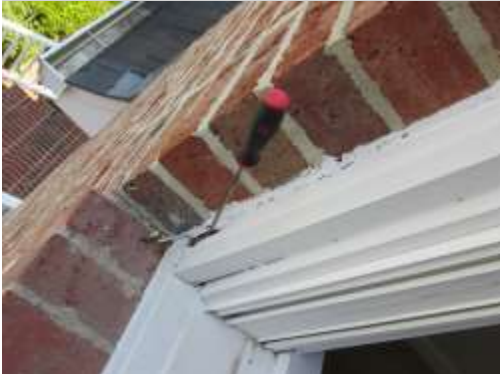
(B2 - 1.3) All Windows

Additional Photograph: This a photograph of a second floor window, decay was noted in all accessible windows.

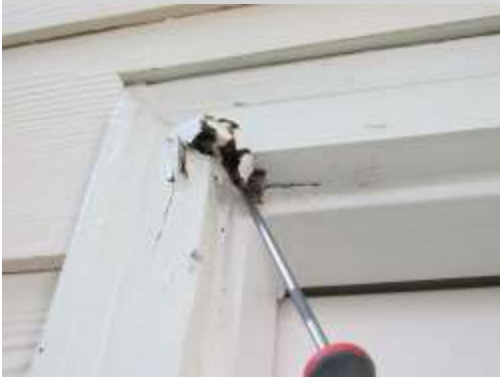
(B2 - 2.1) Door

The door has extensive soft and decayed wood in the frame area . Decay in the door frames can result in leaking and water penetration and should be repaired as soon as possible. A general repair specialist or licensed general contractor should be consulted for evaluation and repair.

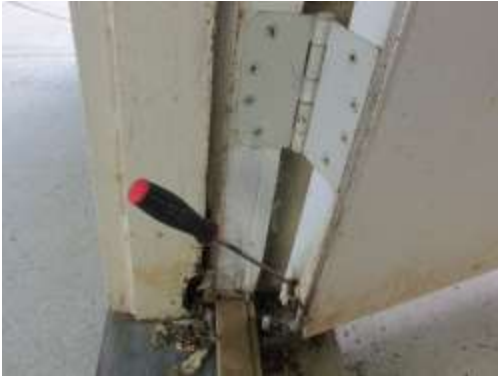
(B2 - 2.2) Door

Additional Photograph: The door also has soft and decayed wood in the door panel area. Decay in the door panel can result in leaking and water penetration and should be repaired as soon as possible. A general repair specialist or licensed general contractor should be consulted for evaluation and repair.

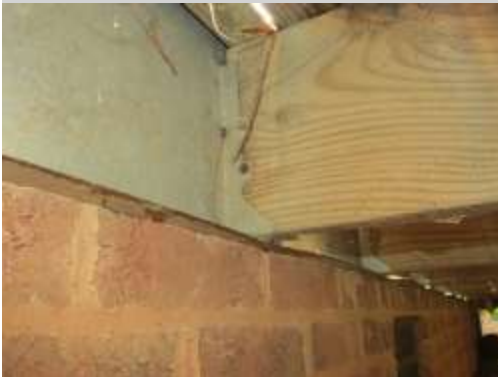
(B3 - 1.1) Deck Sample 1

The metal hangers used to support the floor framing of the deck were installed without the proper number and sized nails. The nail installation is crucial to the function of the hanger, without proper installation the hanger could fail allowing the deck to move or collapse. A licensed general contractor should be consulted for complete evaluation of the deck and to make necessary repairs.

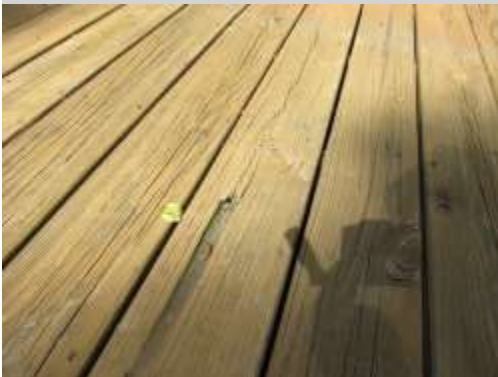
(B3 - 1.2) Deck Sample 1

The wood deck was found to be severely weathered. Decking boards were splintering and cupped. The deck should be considered hazardous. A licensed general contractor should be consulted for complete evaluation of the deck and to make necessary repairs.

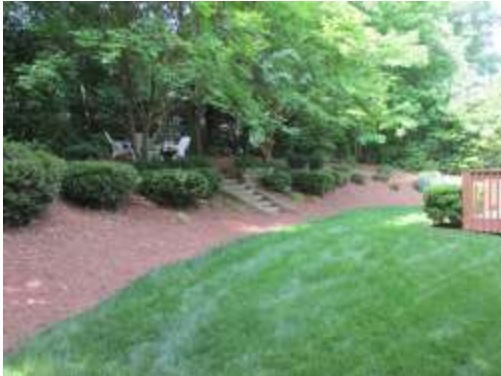
(B5 - 1.1) Grading

The rear yard slopes toward the home and there is evidence of erosion of soil along the sides yards that is directing drainage against the perimeter of the home. Corrections are needed to control drainage and prevent water penetration, a licensed general contractor should be consulted for a complete evaluation and to make necessary repairs.

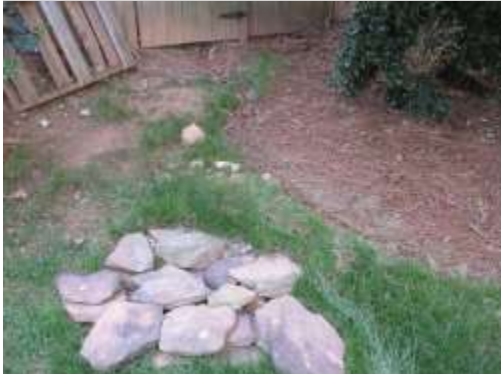
(B5 - 1.2) Grading

Additional Photograph: Evidence suggests that the drainage from the rear section of the lot accumulates along the fence and left foundation wall.

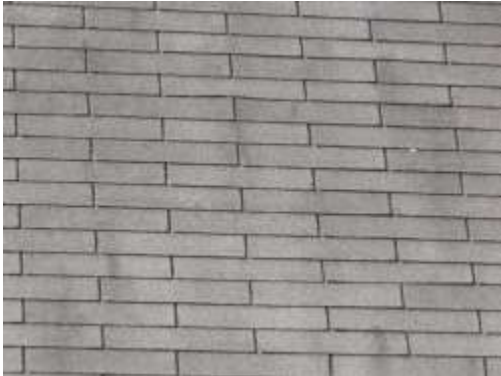
(C1 - 1.1) All Accessible Areas

The roof shingles were noted to be lifting or curling at the corners of the tabs. Since shingles are designed to lay flat to shed water and debris, the curling can result in trapped moisture and leaks. Shingle curl for several reasons including: end of the service life, improper installation and or limited ventilation. A licensed roofing contractor should be consulted for a complete evaluation of the roof covering and flashings system to make necessary repairs to ensure the weathertightness of the roof covering system. At the time of the repair, the roofer may be able to answer questions related to the life expectancy of the roof covering system.

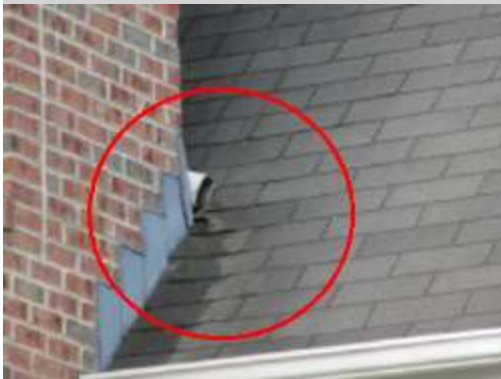
(C2 - 1.1) All Accessible Areas

The gutter downspout at the right dormer is not extended or piped out to direct roof drainage away from the side wall of the main home. Direct drainage from the gutter system can result in direct water penetration into the attic areas of the home. A licensed general contractor should be consulted for a complete evaluation and to make necessary repairs.

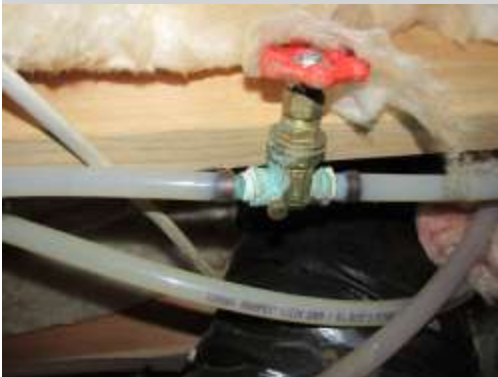
(D1 - 1.1) All Accessible Areas

The main water supply line located in the crawl space at the back door is corroded. Corrosion on the main water lines should be addressed as soon as possible to prevent major leaks and property damage. A licensed plumbing contractor should be consulted for a complete evaluation and repair of the main water supply line.

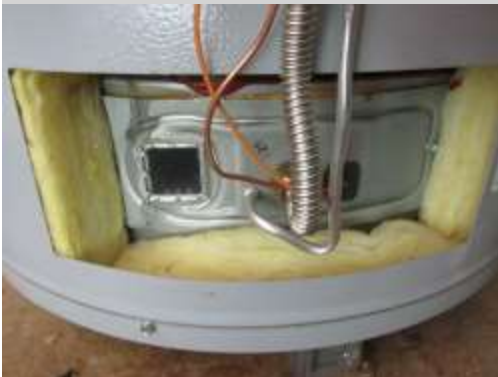
(D3 - 1.1) Unit #1

There was no hot water available for the main home during the inspection. The gas service to the unit was off. The inspector did not have permission or knowledge of the circumstances that required the unit to be turned off and therefore did not turn the unit on. The inspection of the hot water heating unit, fixtures, and appliances was limited and not completed. It is recommended that the hot water be restored and the inspection completed prior to the purchase of the home.

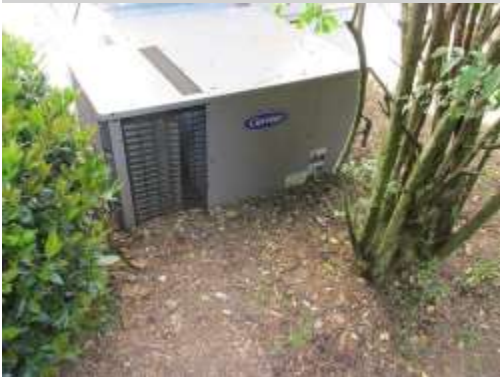
(F1 - 1.1) Heating Unit #1

The grading around the package HVAC unit is directing drainage toward the unit. Evidence suggests that water from lot drainage has been entering the unit., see next photograph. Drainage needs to be corrected to prevent damage to the unit. A licensed general contractor should be consulted for further evaluation and repair.

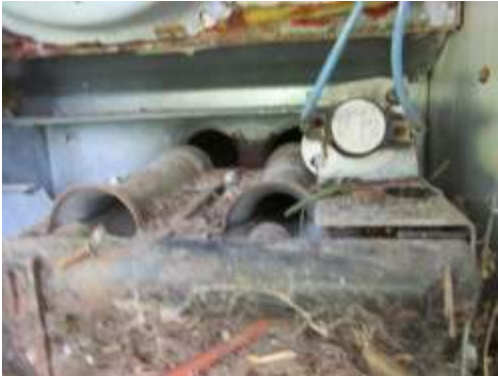
(F1 - 1.2) Heating Unit #1

The gas burner section of the package unit has visible rust and debris in the burner chamber area. The rust indicates deterioration of the exchanger. Deterioration of the heat exchanger is a serious concern that can result in improper combustion and carbon monoxide poisoning. The furnace needs a complete evaluation which should include a heat exchanger inspection to ensure safe, reliable, and proper operation of the HVAC system. A licensed HVAC contractor should be consulted for repair.

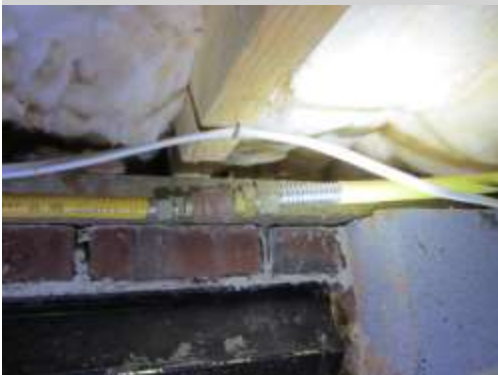
(F3 - 1.1) Crawl Space

This home has corrugated stainless steel gas lines. This gas line has specific installation requirements related to required bending allowances, support, protection, and electrical bonding to ensure safe conditions. The electrical bonding is typically required to prevent damage from electrical storms in the event of a lightning strike. During the home inspection the bonding attachment could not be located. An electrical contractor should be consulted for a complete evaluation of the CSST installation and to verify the presence of electrical bonding.

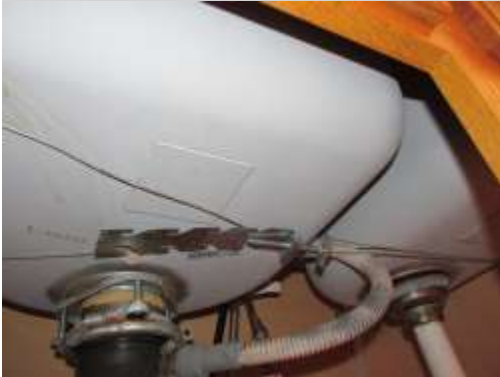
(H2 - 1.1) Kitchen

The sink is in need of further evaluation and repair. The following concerns were noted at the time of the inspection:
1. The sink is supported by a wire and bracket was not secure.
A general repair specialist or licensed general contractor should be consulted for evaluation and repair.

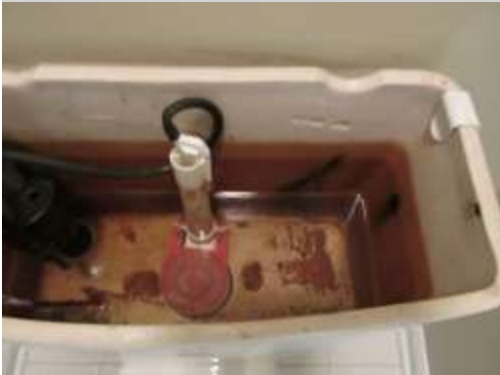
(H3 - 1.1) Bathroom #1 Master

The toilet flush valve is not operating properly. This could result in improper functioning, flooding and waste of water. A licensed plumbing contractor should be consulted for evaluation and repair.

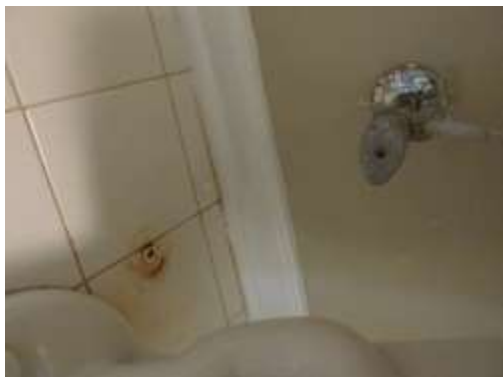
(H3 - 2.1) Bathroom #2

The floor area under the toilet tank has a rust stain indicating a history of a leak or a seeping leak at the tank bolts or water turn off. The toilet tank bolts/gaskets and the turn off valve need to be evaluated by a plumber to ensure that they are not leaking. A licensed plumbing contractor should be consulted for evaluation and repair.

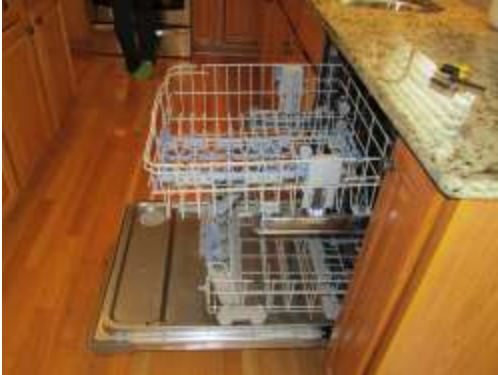
(J1 - 1.1) Dishwasher

The dishwasher is not secure to the cabinet and it moves forward when the door is opened. The appliance needs to be secured to the cabinet to prevent damage to the unit or personal injury. An appliance repair person or general contractor should be consulted for repair.
